TECHNICAL INSPECTION REPORT

(6) OPERATION CROSSROADS.
U.S.S. BRACKEN (APA64).

OPERATION CROSSROADS

USS BRACKEN (APA64)

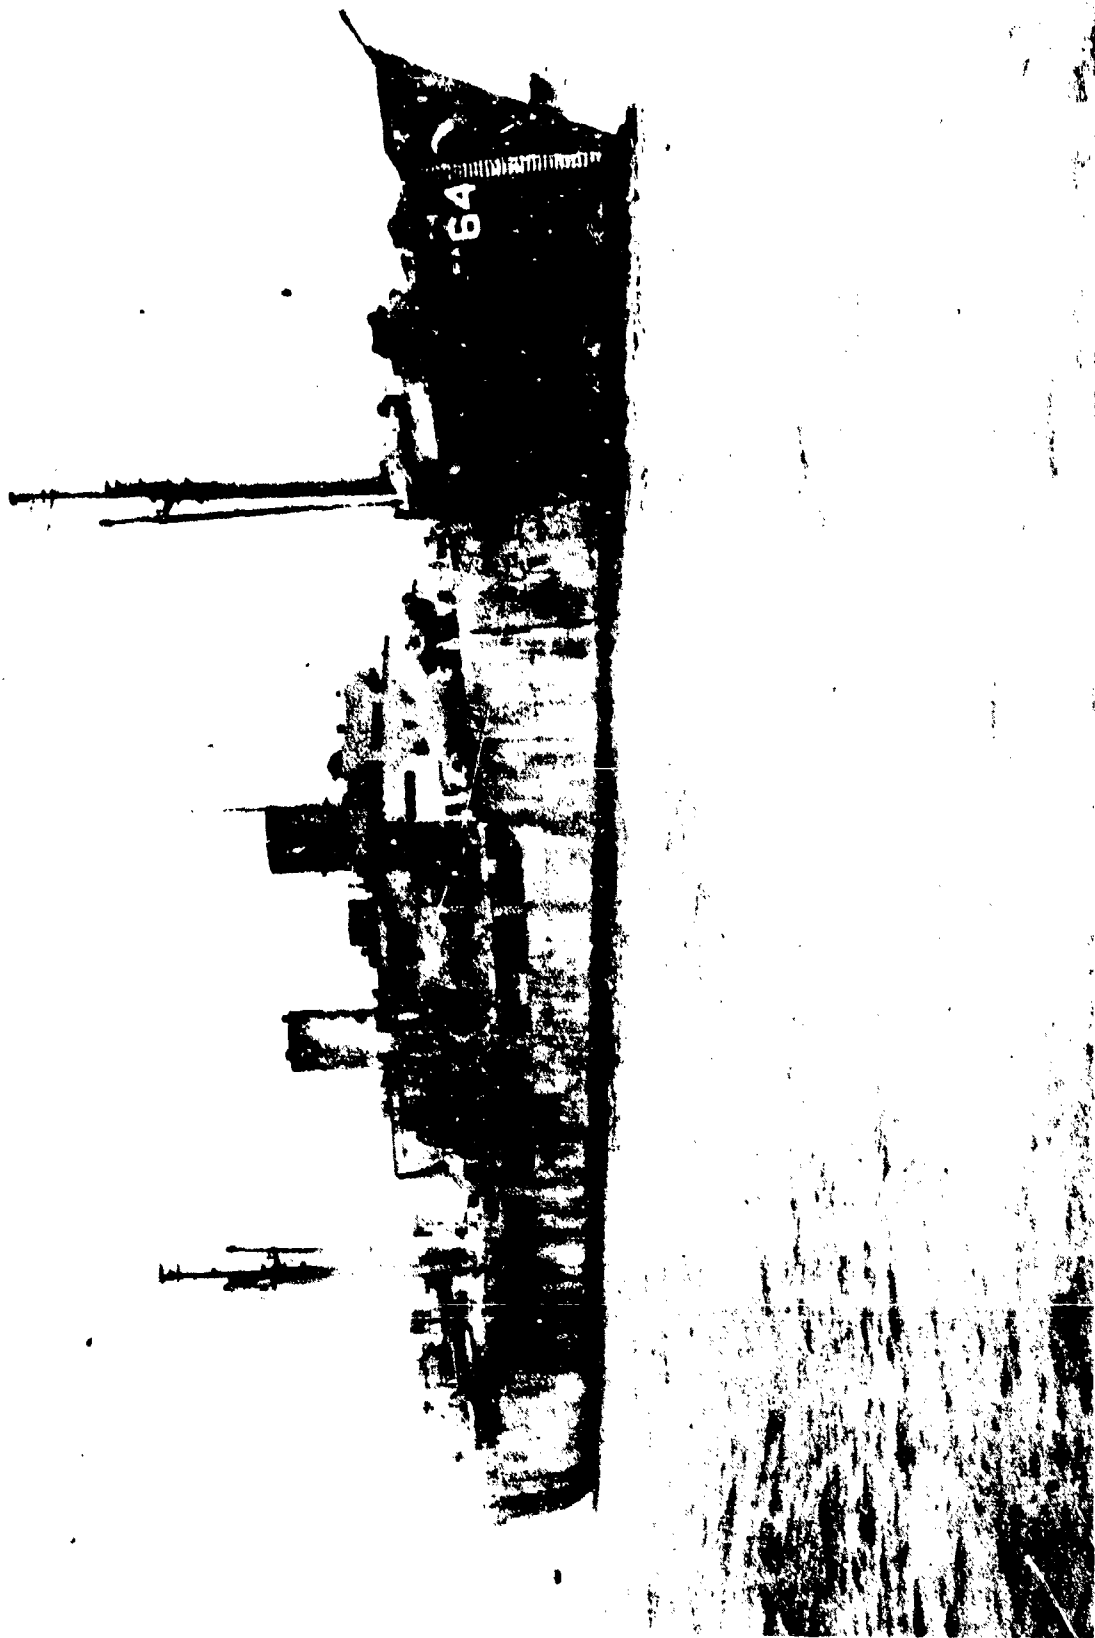
AB-CR-227-289-30. View from off starboard bow after Test B.

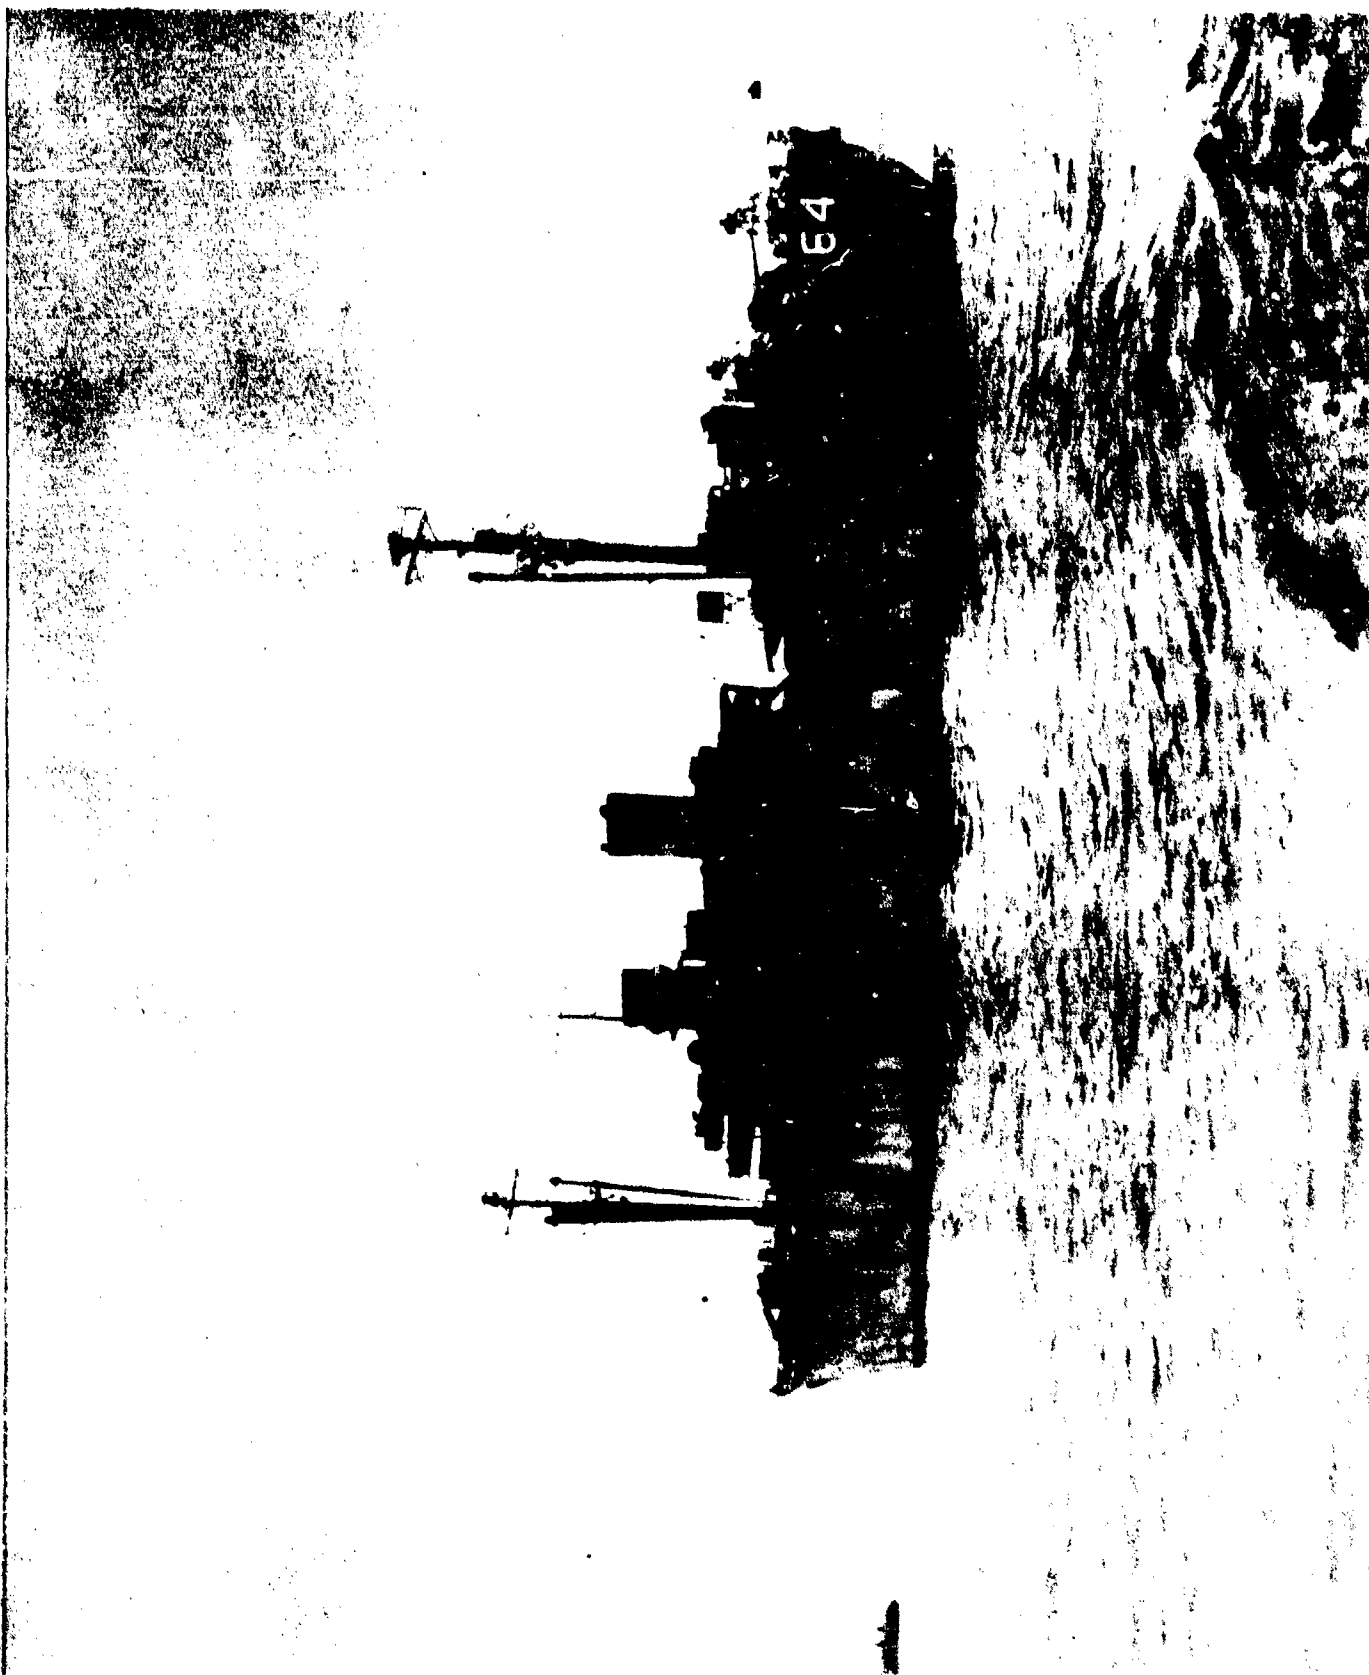
AB-CR-227-289-26. View from off port quarter after Test B.
